CONTROL SURVEY MONUMENT RECOVERY

Cathedral City

Number: **110**

Name: **LANDAU / VISTA CHINO**

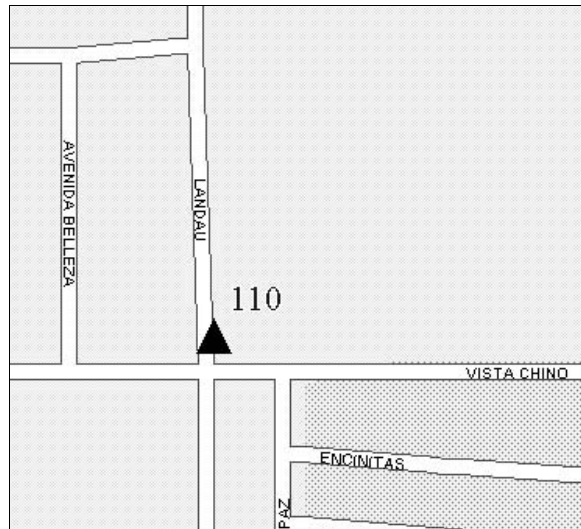
Monument Description: GPS Useable: Yes
Set Cathedral City bronze disk in concrete slab

At the northeast corner of Landau Blvd and Vista Chino

Approximately 40 ft northerly from Vista chino
